Manhole Inspection Summary

Manhole # S51M__031MH

Insp Date: **4/14/08 12:11 PM**

Location Address: **911 kenwood streeper**

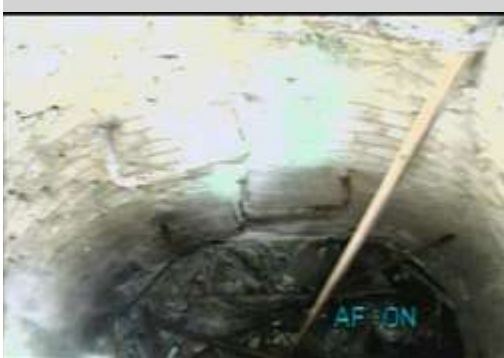
Defect 3

Condition: ☐ Sound ☐ Cracked ☐ Root Intrusion ☐ Deteriorated ☐ Leaks ☒ **Debris**

channel debris (heavy)

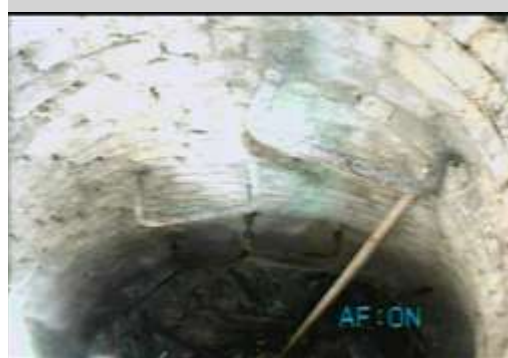
Defect 2

Steps Count: **5** Missing: **0** ☒ **Corroded**

corroded stair

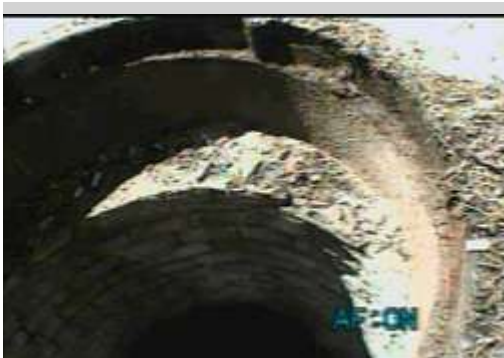
Defect 1

Frame Offset: **4** (in.) Condition: ☒ Sound ☐ Cracked ☐ Leaks

Condition: ☐ Sound ☐ Cracked ☐ Root Intrusion ☒ **Loose Brick** ☐ Deteriorated

off set frame, loose bricks

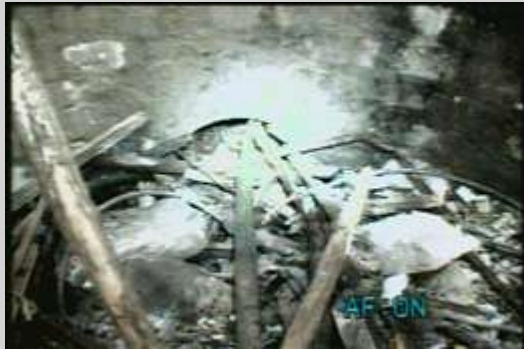
12 O'Clock Outflow

Deposits: ☐ None ☐ Mud ☐ Sludge ☒ **Debris** ☐ Grease

Silt Depth: **7** (in.) Deposits Extent: **Heavy**
